The Owner's Guide to Piano Repair

Focus On: Replacement of Worn Asian-Design Hammer Butts and Flanges

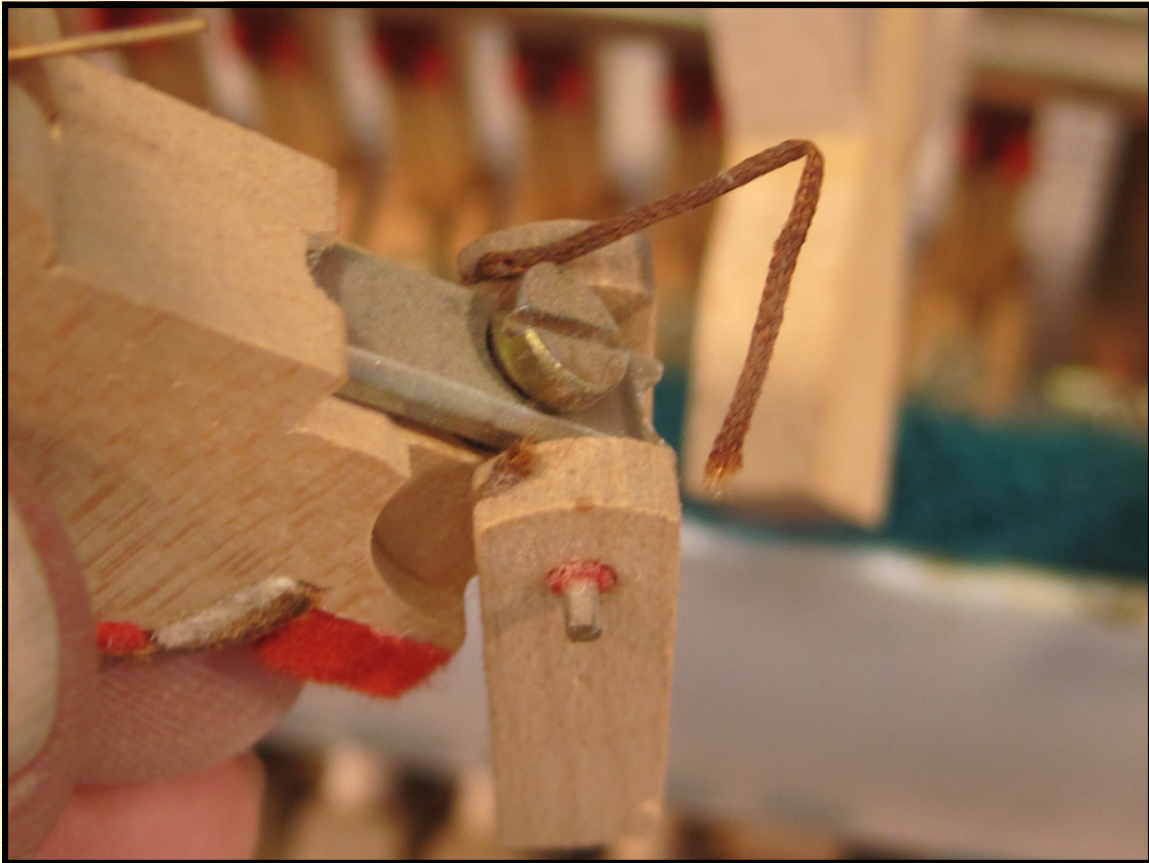
The Achilles heel of Yamaha, Kawai and other Asian-made pianos is a hammer butt assembly that relies upon a small braided cord to hold an essential spring in check. After years of use this cord is prone to breaking (as shown in photo on cover), which causes the piano action to perform unsatisfactorily.

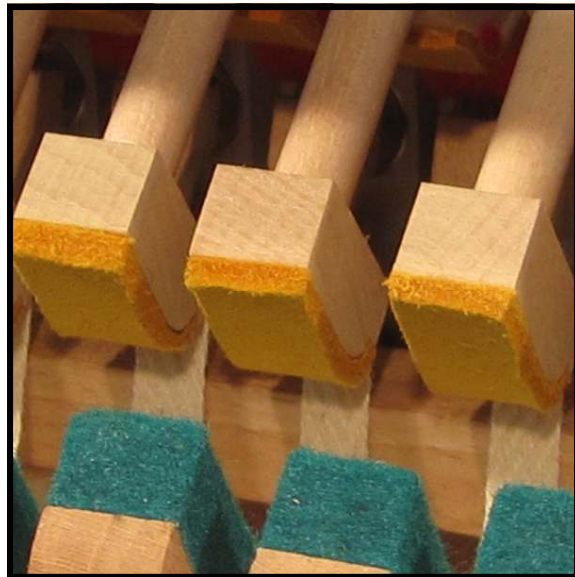
Old hammer butts

Replacement hammer butts

Consider the above photos showing a part called the catcher, which is faced with a buckskin (or similar) covering. When a note is played, this part is essential to preventing repeated strikes (called "bobbling" notes). The buckskin surface wears thin over the years, especially on portions of the keyboard which are played more heavily. In the photo on the left showing a set of original hammer butts, the buckskin covering the center catcher has worn thinner than the two adjoining catchers. The photo on the right shows the new catchers of replacement hammer butts. Not only is the buckskin covering uniform in thickness, providing a consistent cushion to the parts coming together, but it has a better ability to make a secure contact with the backchecks (the thick green felts at the bottom of the photo). The rougher texture of the new buckskin will grab the backchecks without slipping, as older, worn buckskin is prone to do.

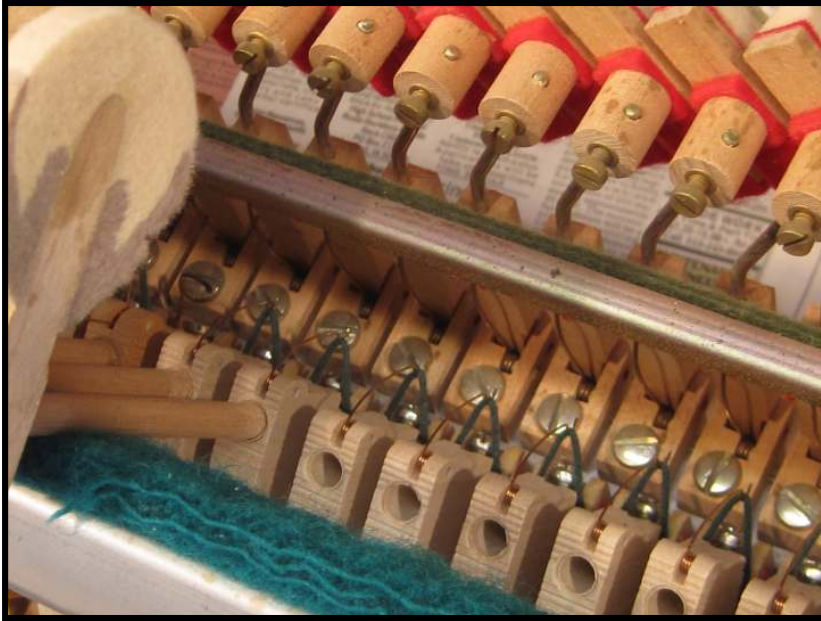
The hammer shanks are then dry fitted into the new hammer butt assemblies. With all the hammers in place, careful alignment will be done, and only then will the parts be glued together.
